Six Months Since Western Japan Flood

Lessons from Mabi

CWS JAPAN

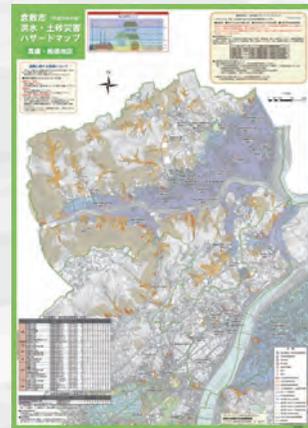
Hazard Map of Kurashiki City (Source: City Website)

The town was required under a 2005 law to create “Hazard Maps” outlining areas at high risk of flooding, landslides and other disasters, and the locations of evacuation centers. But the official hazard map was distributed only in 2016, by which time most of the high risk areas were already occupied. The map clearly mentions about the risk of severe flooding and the possible frequency (every 100 or 150 years), where the water may rise as high as 5 meter. Unfortunately most residents did not comprehend the level of risk even after the Hazard Maps were distributed to them. The residents were also unaware of Backwater Phenomenon, where the smaller rivers become much more dangerous. It is necessary to raise the awareness in community level by holding meetings, side by side with distributing individual hazard maps. A booklet with comprehensive explanation about the risks and the necessary protective measures can also help the residents take timely actions in both individual and community level.

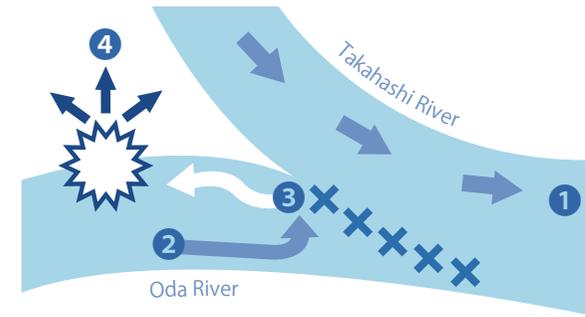
How backwater phenomenon occurred in the Oda River

- 1 Water level rises due to rain.
- 2 Water level rises as downstream flow is stopped by the Takahashi River with a rising water level.
- 3 Stagnant flow pushes up water level further.
- 4 Barks breach and flood occurs.

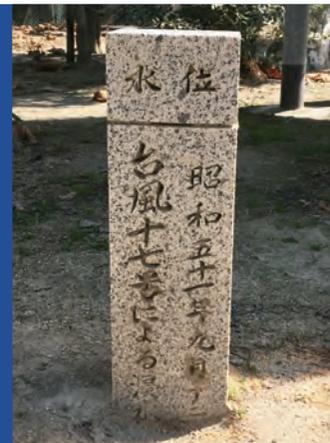
A stone in the playground of Kawabe Elementary School shows the maximum water level after the September 1976 typhoon (about 50 cm).

Mabi has a history of devastating floods. In 1893, the Oda river overflowed following heavy rainfall and it is said that the flood water went as high as 14 meter (picture below). In recent years, especially since the 70s, the town has seen repeated floods almost every few years, but the water level never exceeded 50 cm. This, unfortunately, had resulted in the general misperception that the water could never ever go above that height.

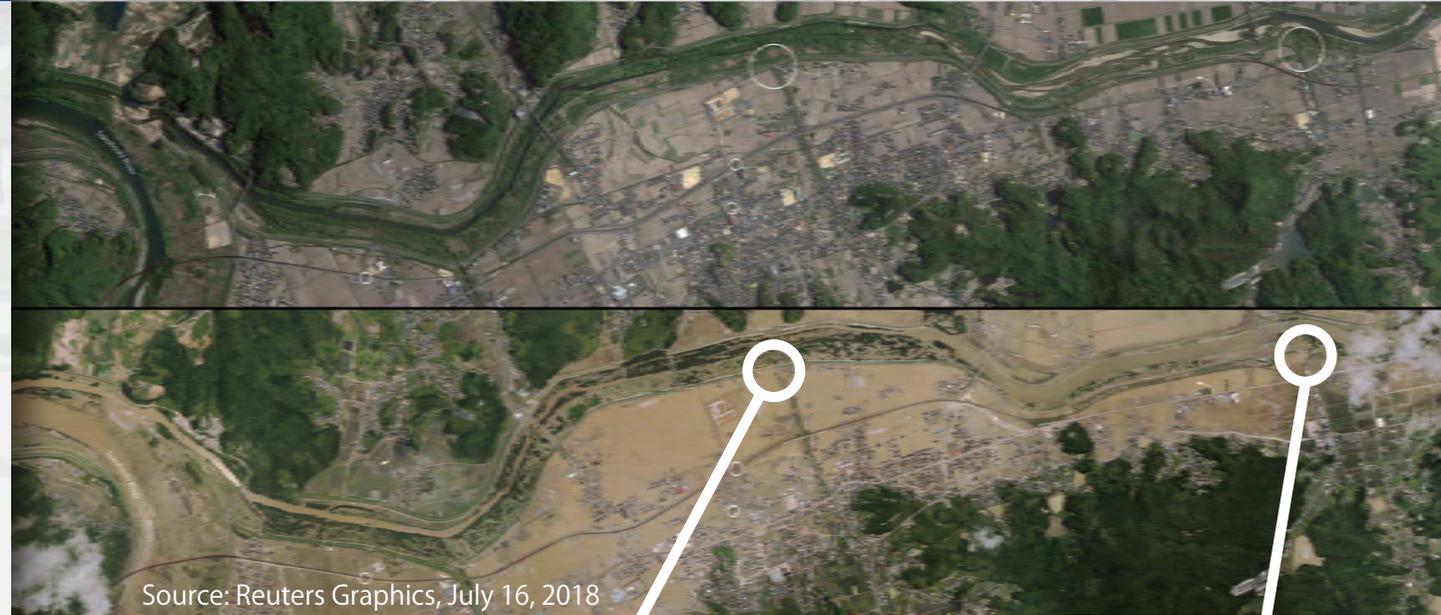
Source: Reuters Graphics, July 16, 2018

The water level of the Suemasa river increased due to heavy rain, and about 1 km north from its meet point with the Oda River, a bridge collapsed.

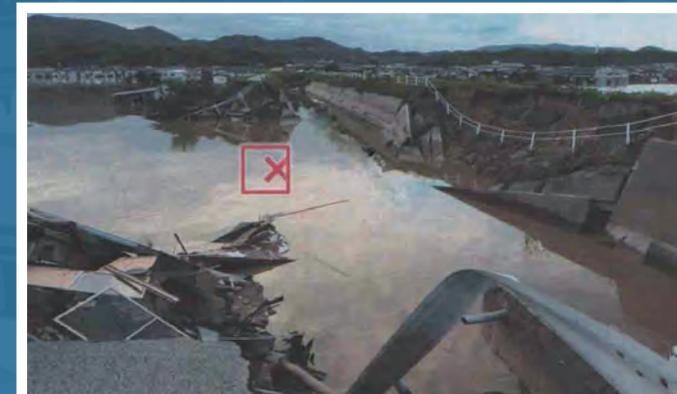
The Takama river meets the Oda river at Mabi town of Kurashiki City, and the embankment at the meet point of the two rivers broke down.

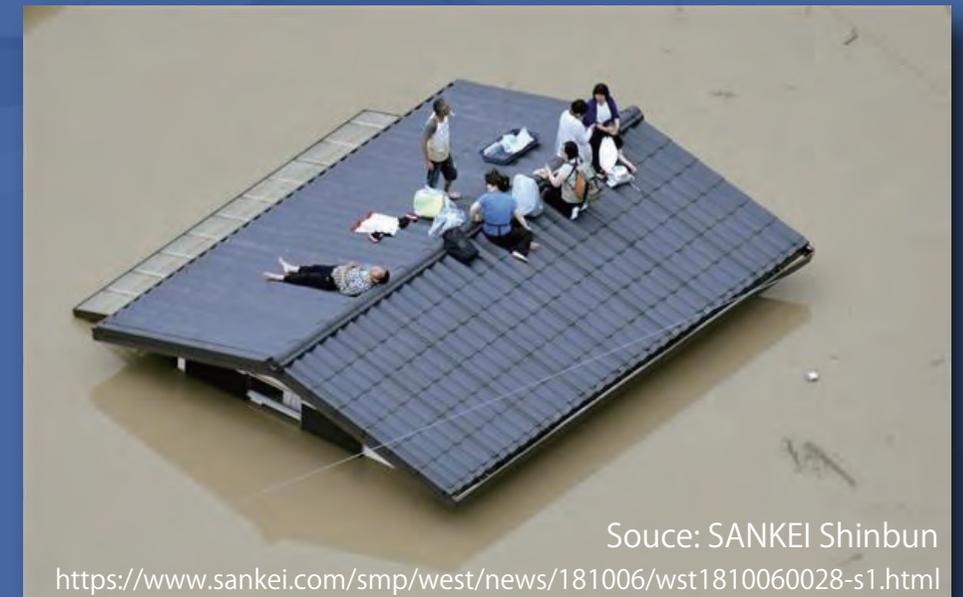
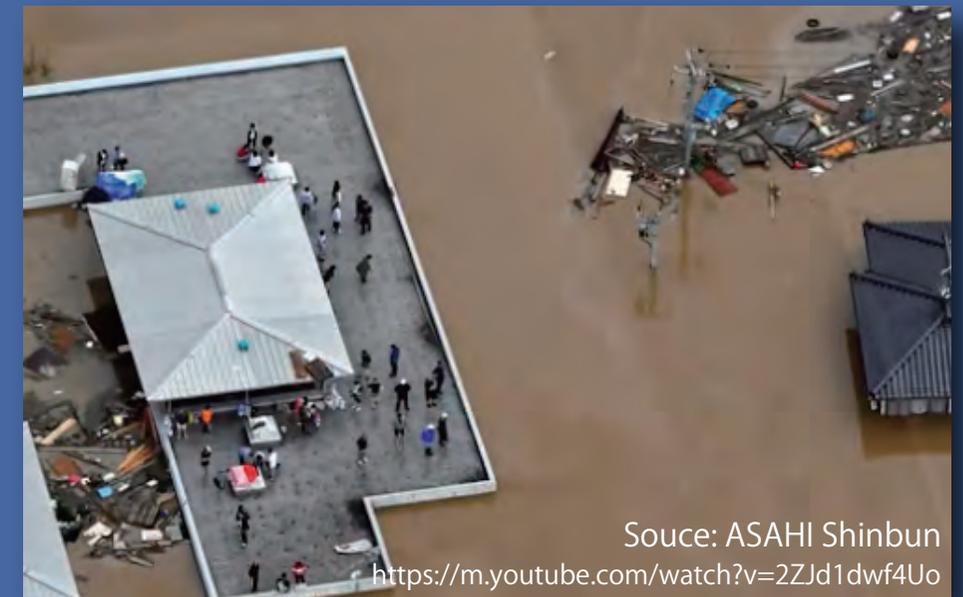
Diagram of Warning Systems

Morning of July 7

In Kurashiki City and the nearby areas heavy rain had started since the morning of July 6th. The weather forecast showed continuous rainfall over the next two days, and the city office was getting prepared for an emergency since the morning of July 5th. The first evacuation order for the area south of the Oda river was issued at 11:45 p.m. on July 6th. Some residents said that they did not know the difference between an emergency warning and an evacuation order. Some came to know about the difference through social media after the warning was issued. At 1:30 a.m. on July 7th, using loudspeakers, mobile phone alerts, and television and radio messages, the city ordered residents in the heavily populated area north of the river to seek shelter. Only four minutes later the failure of the first levee on Takama river was confirmed. Within the next few hours four more levees broke down, flooding one-third area of the entire town.

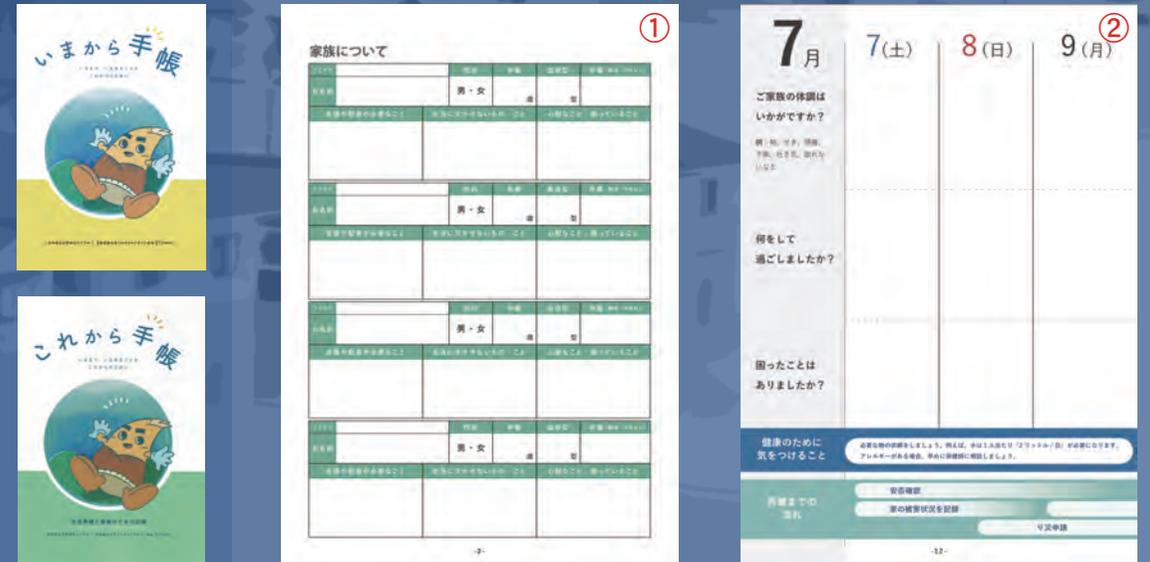
Imakara Techo: Diaries From Now

- ① Basic information about each family member.
- ② A Calendar to record health conditions. The lower rows contain health advices (in blue) and certain things that need to be done till one can get back to normal life (in green).

CWS Japan supported a team from Kochi University to create and disseminate Imakara-Techo (Diary from Now) to help evacuees manage their “assessment fatigue” and create integrated information about themselves and their situation to be shared with all agencies and aid providers for their recovery. This proved to be a very useful tool to share all their basic information, situation details, medical records and other information so that they don’t need to answer similar questions repeatedly. The concept of this diary came from Dr. Sakiko Kanbara, the head of global program for disaster nursing at Kochi University, through her years of experience in Nepal and Japan. A team of students of Tama Art University’s Product Design Department, guided by their teacher, gave it shape based on their close observation of the situation in Mabi. After the success of Imakara-Techo, a new version called “Korekara-Techo” was developed and distributed by the same parties towards the end of October. The diaries are now available online (Japanese only), which was developed by an Okayama based company called Rhizome KK. (Website: <https://app.imakara-techo.com/login>)

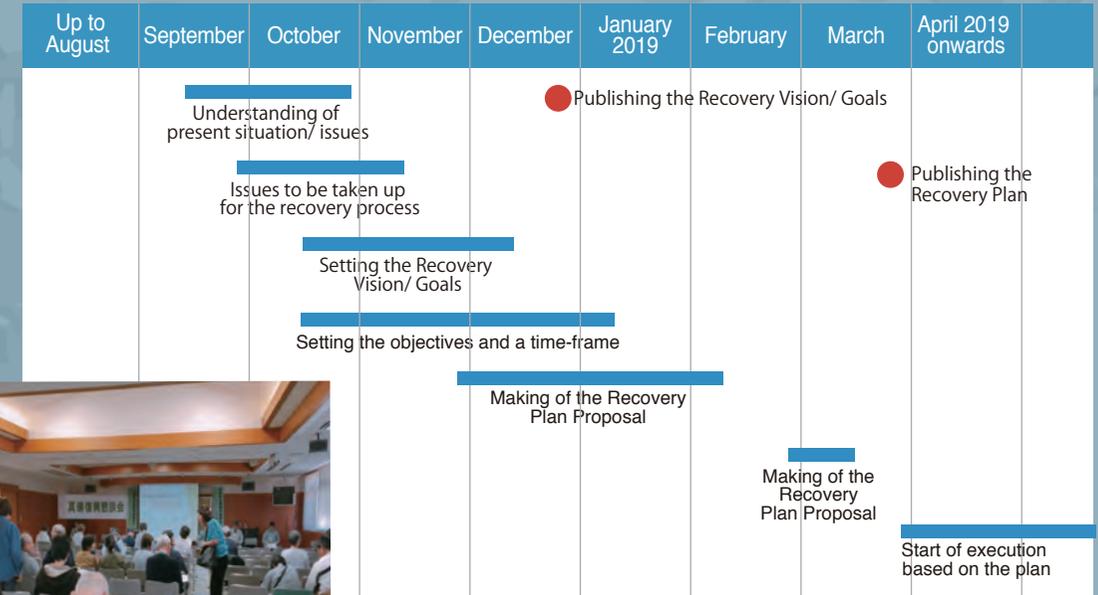
Tentative recovery plan given by the City Chief at the opinion exchange session with the residents of Kawabe area on November 10, 2018

1 Reconstruction of Infrastructure

By year 2023 a bypass of the Oda river will be created 4.6 km downstream from its present meet point with the Takahashi river (from the government's emergency disaster management budget). Embankments and levees will be made stronger and higher at several areas along the Oda river.

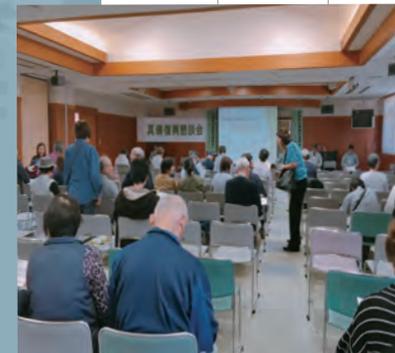
How Information is Collected and Shared in mabi-care.com

Mabi Care is a website that collects and shares all the information the residents of a post-disaster town may need during the recovery process. About a week after the flood, Dr. Sakiko Kanbara of Kochi University, who was born and raised in Mabi, realized that the residents, most of whom lost their cars and were staying in a shelter in an entirely different neighborhood, needed information about various kinds of facilities to slowly start getting back to normal life. All the information needed to be in one place, yet needed to be very simple to search. During her field survey she found that some of the facilities within Mabi and the nearby areas, like convenience and drug stores, toilets and supermarkets, were unaffected and were operating. Mabi Care collects and updates the location and opening hours of all those facilities and more, from which the residents have been greatly benefitted.
